**EFFECTS OF ENVIRONMENT ON CREEP BEHAVIOR OF
NEXTEL720/ALUMINA-MULLITE CERAMIC COMPOSITE
WITH $\pm 45^\circ$ FIBER ORIENTATION AT 1200°C
THESIS**

AFIT/GSS/ENY/09-M05

**DEPARTMENT OF THE AIR FORCE
AIR UNIVERSITY**

Degree of Master of Science (Space Systems)

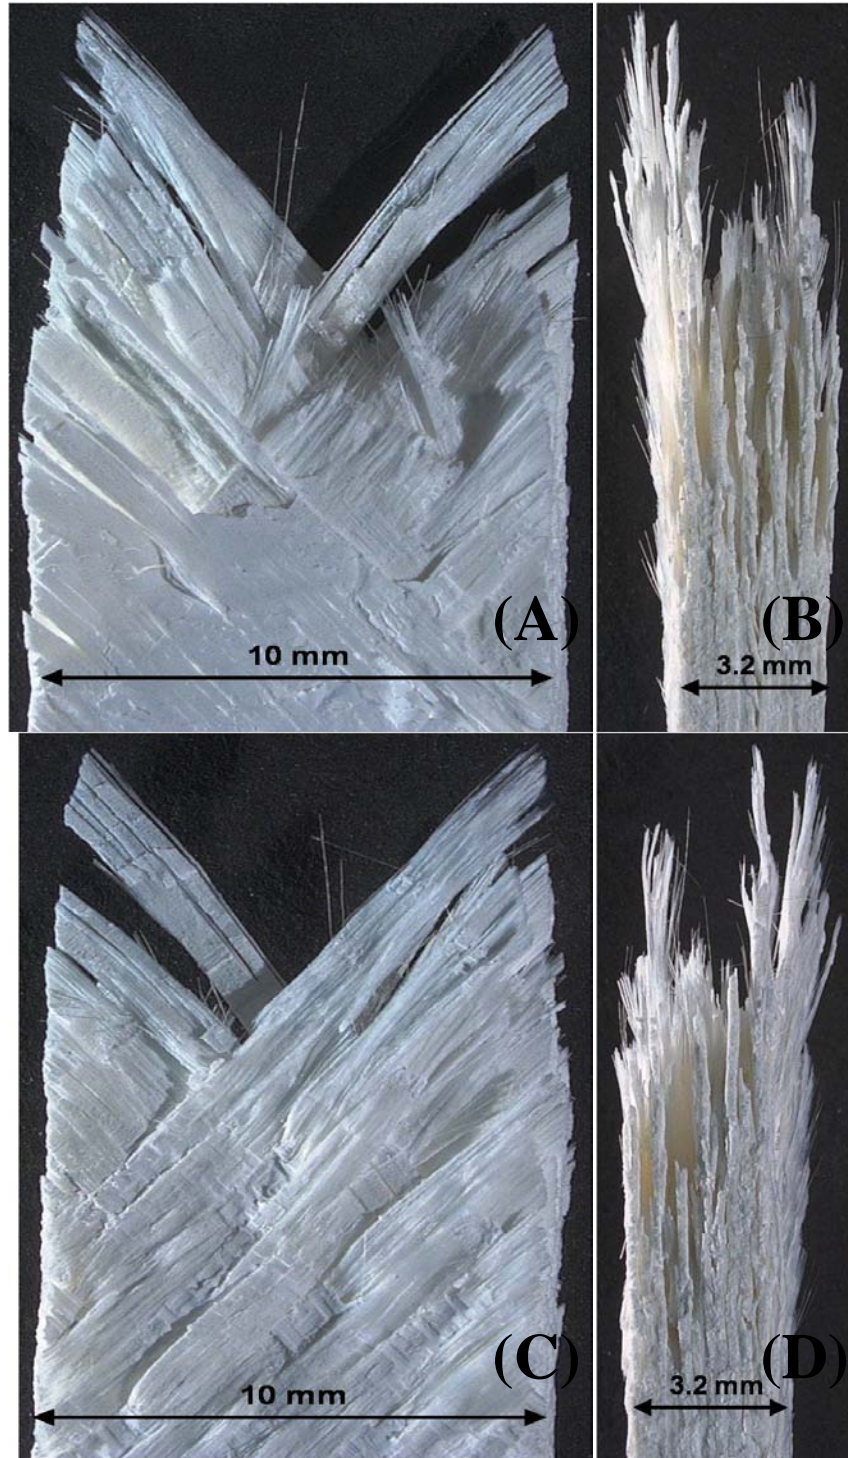
Figure 684. Fracture surface of the N720/AM specimen with $\pm 45^\circ$ fiber orientation obtained in creep test conducted at 30 MPa at 1200°C in argon. Creep lifetime $t_f = 3.42$ h.
 (a)-(c): front view, (b)-(d): side view

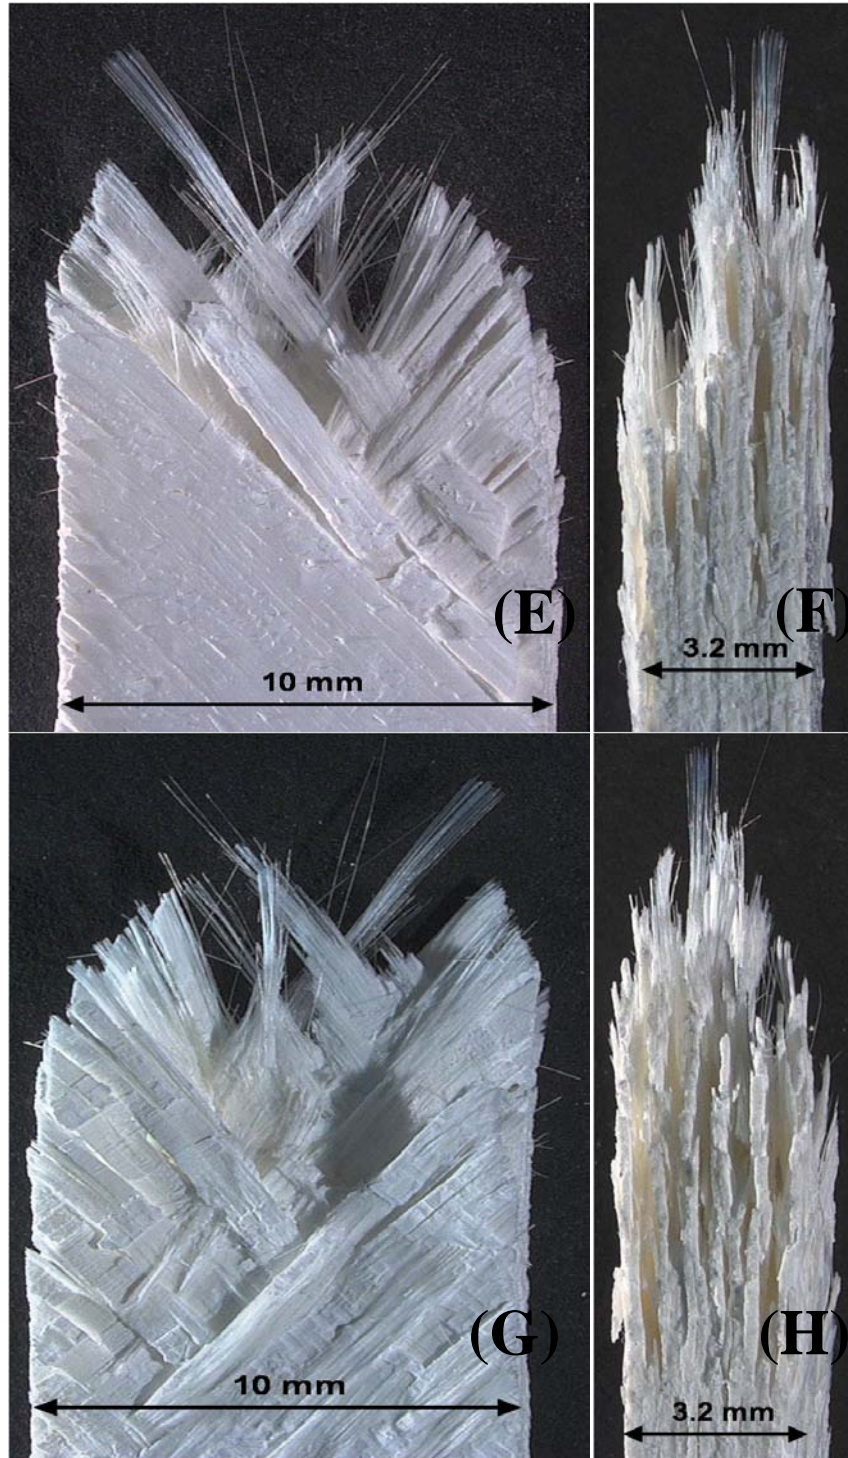
Figure 685. Fracture surface of the N720/AM specimen with $\pm 45^\circ$ fiber orientation obtained in creep test conducted at 30 MPa at 1200°C in argon. Creep lifetime $t_f = 3.42$ h.
 (e)-(g): front view, (f)-(h): side view

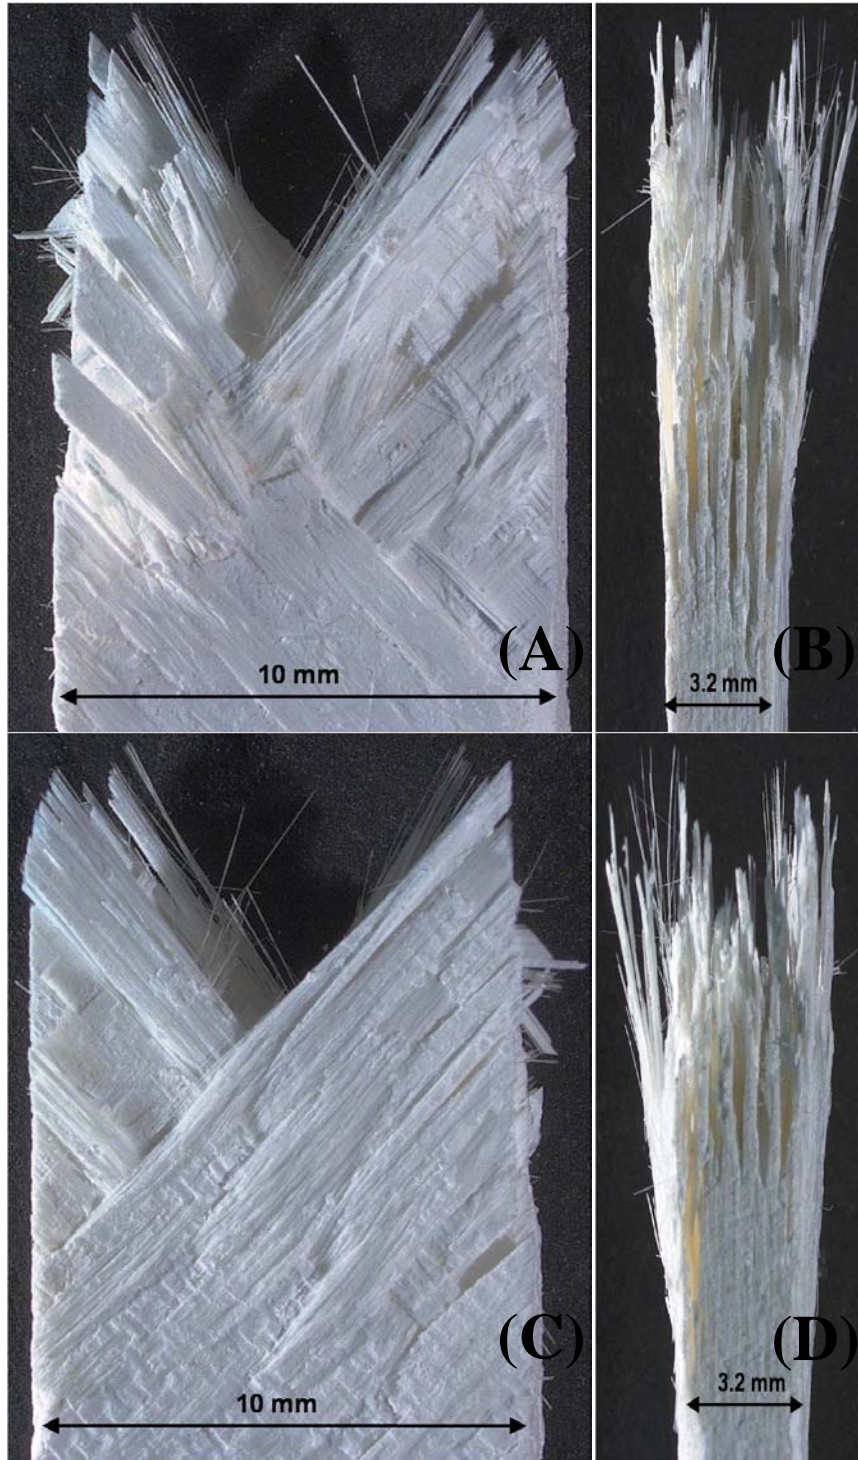
Figure 686. Fracture surface of the N720/AM specimen with $\pm 45^\circ$ fiber orientation obtained in creep test conducted at 32 MPa at 1200°C in argon. Creep lifetime $t_f = 0.08$ h.
 (a)-(c): front view, (b)-(d): side view

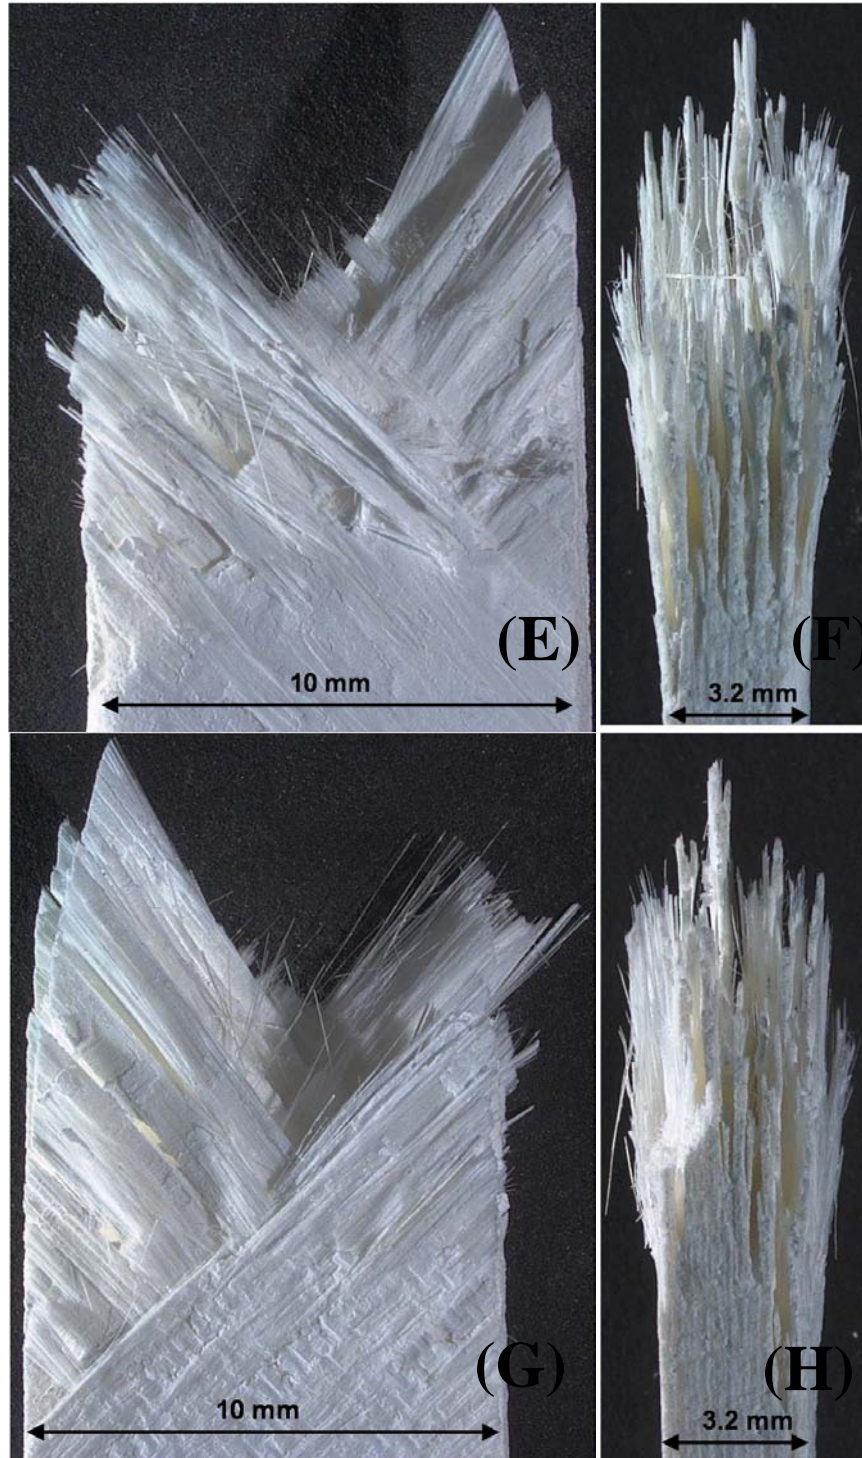
Figure 687. Fracture surface of the N720/AM specimen with $\pm 45^\circ$ fiber orientation obtained in creep test conducted at 32 MPa at 1200°C in argon. Creep lifetime $t_f = 0.08$ h.
 (e)-(g): front view, (f)-(h): side view

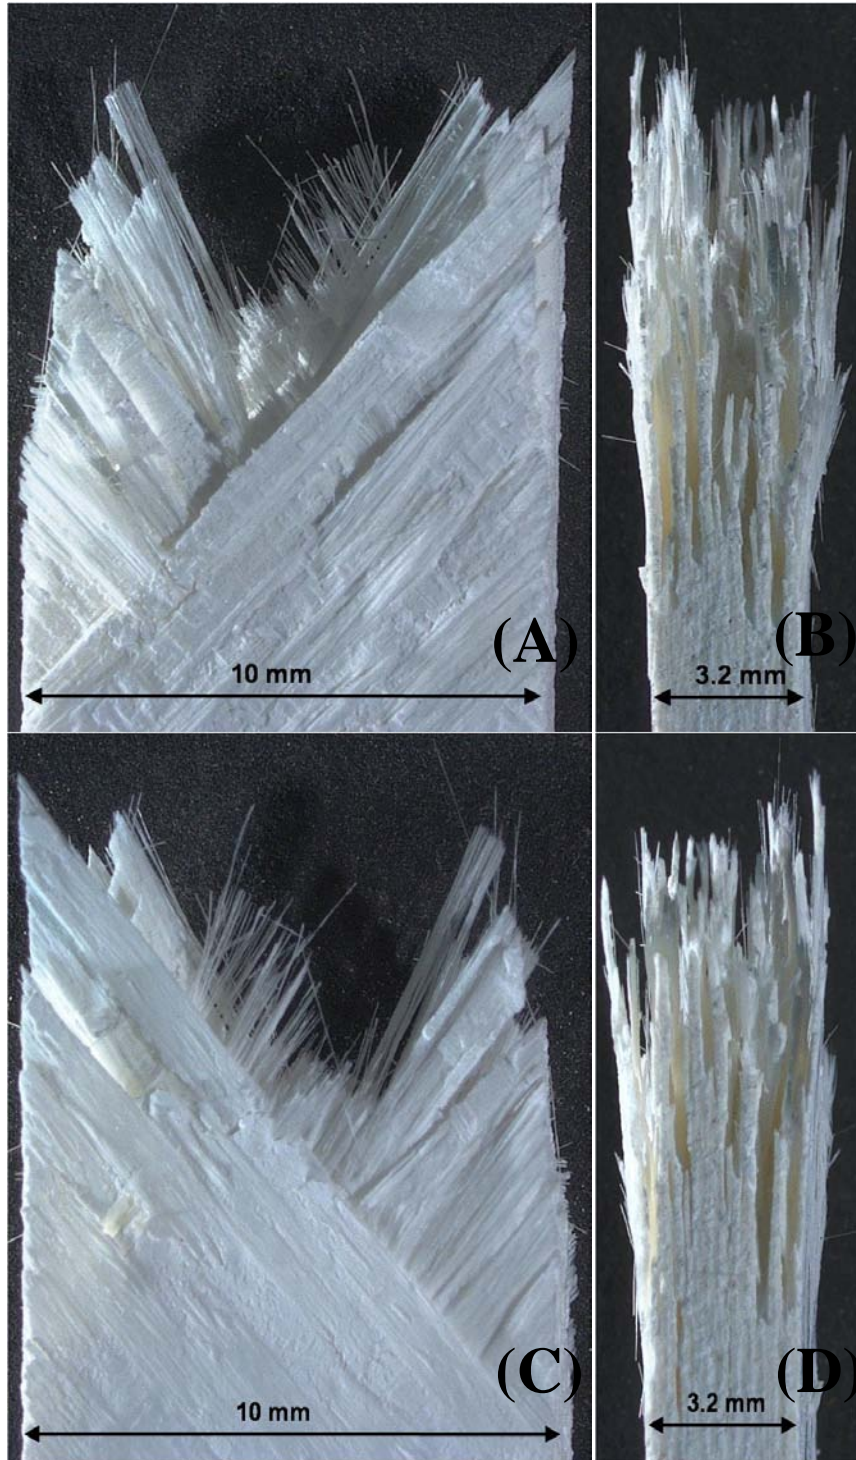
Figure 688. Fracture surface of the N720/AM specimen subjected to tensile test to failure with a constant stress rate of 0.0025 MPa/s at 1200°C in laboratory air. (a)-(c): front view, (b)-(d): side view

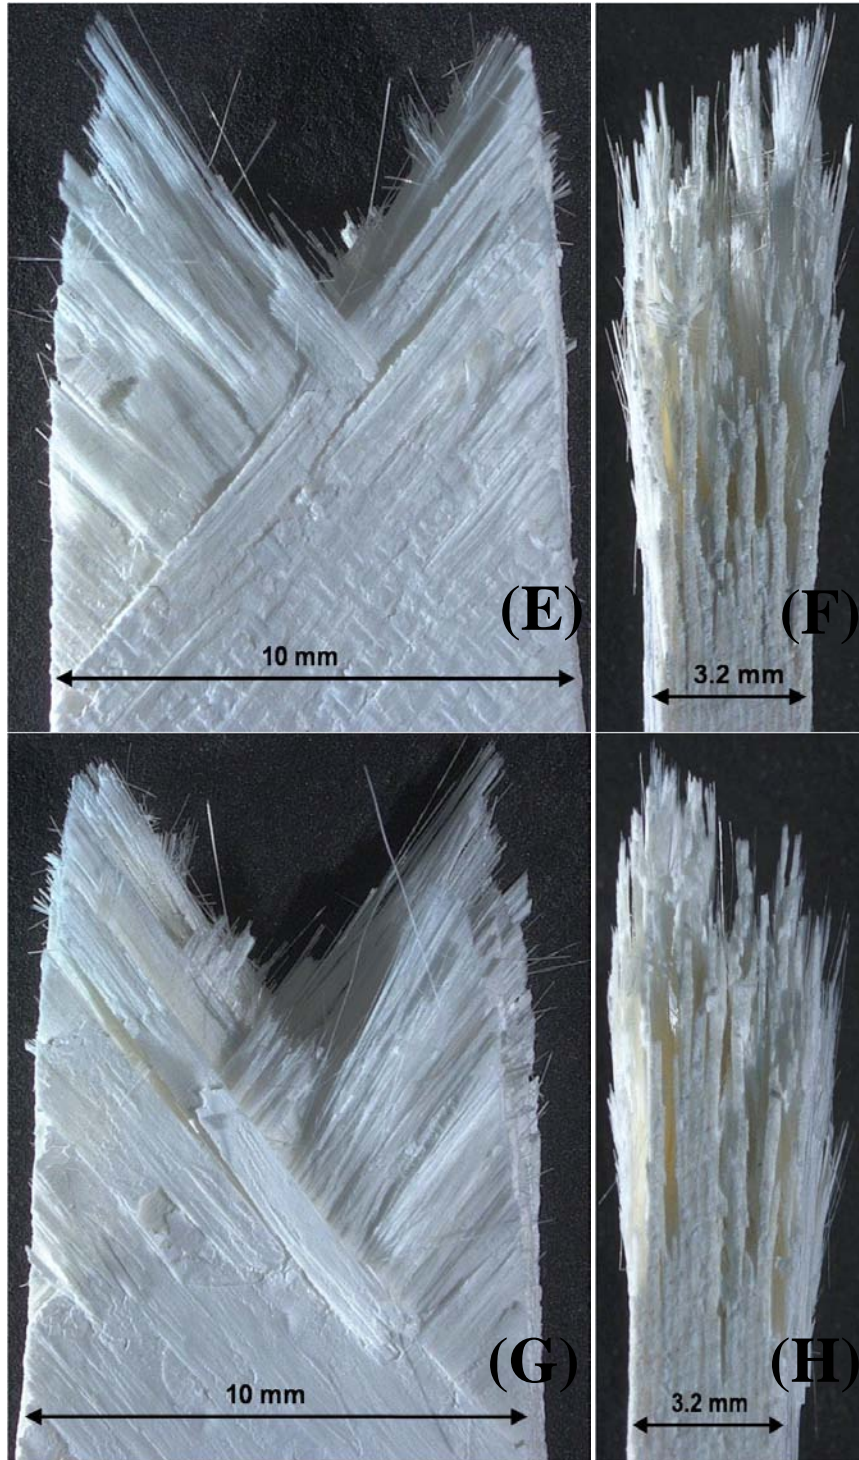
Figure 689. Fracture surface of the N720/AM specimen subjected to tensile test to failure with a constant stress rate of 0.0025 MPa/s at 1200°C in laboratory air. (e)-(g): front view, (f)-(h): side view

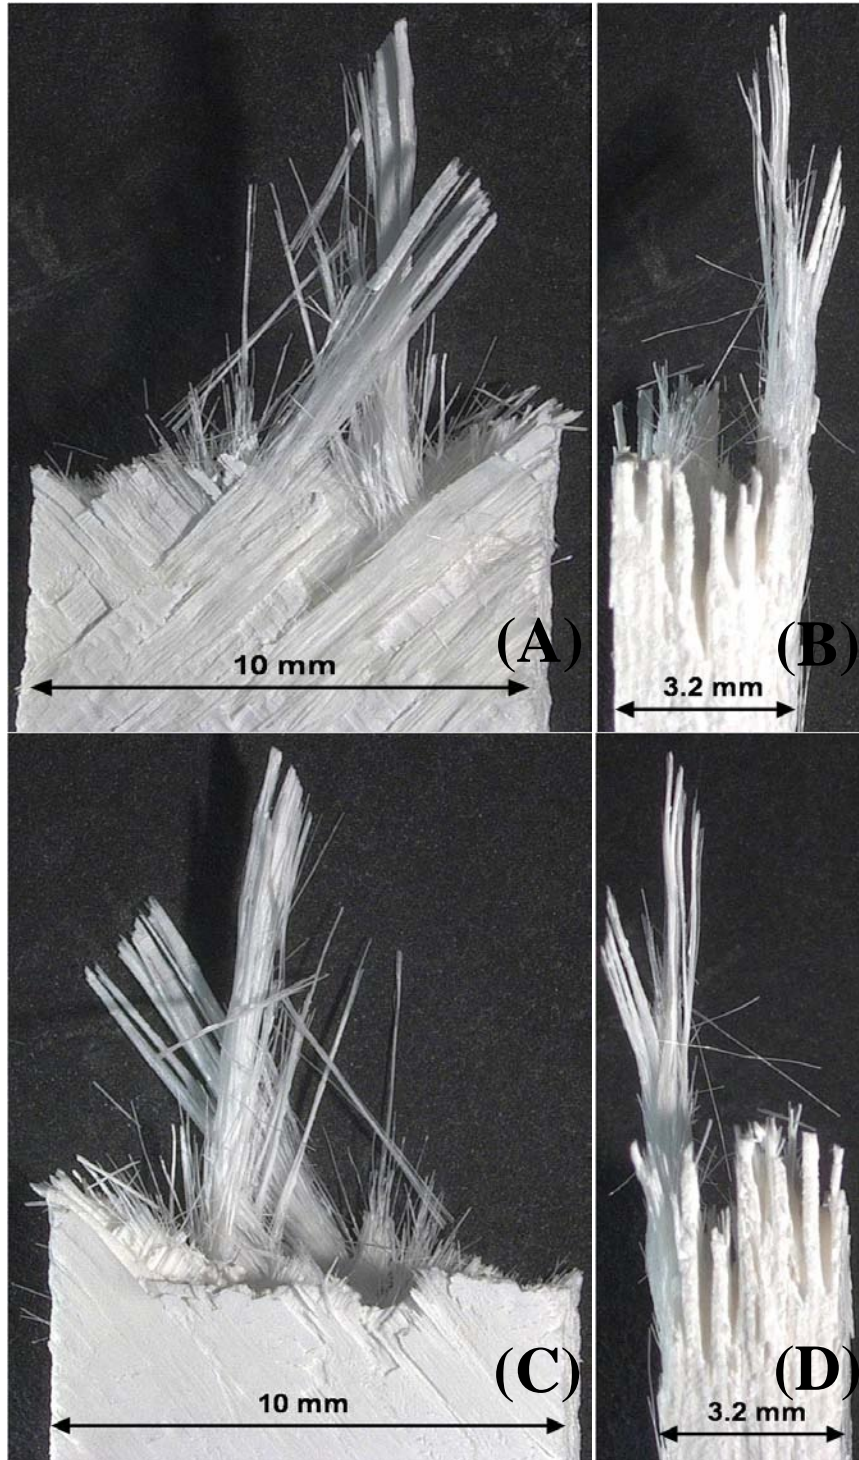
Figure 690. Fracture surface of the N720/AM specimen subjected to tensile test to failure with a constant stress rate of 0.0025 MPa/s at 1200°C in steam. (a)-(c): front view, (b)-(d): side view

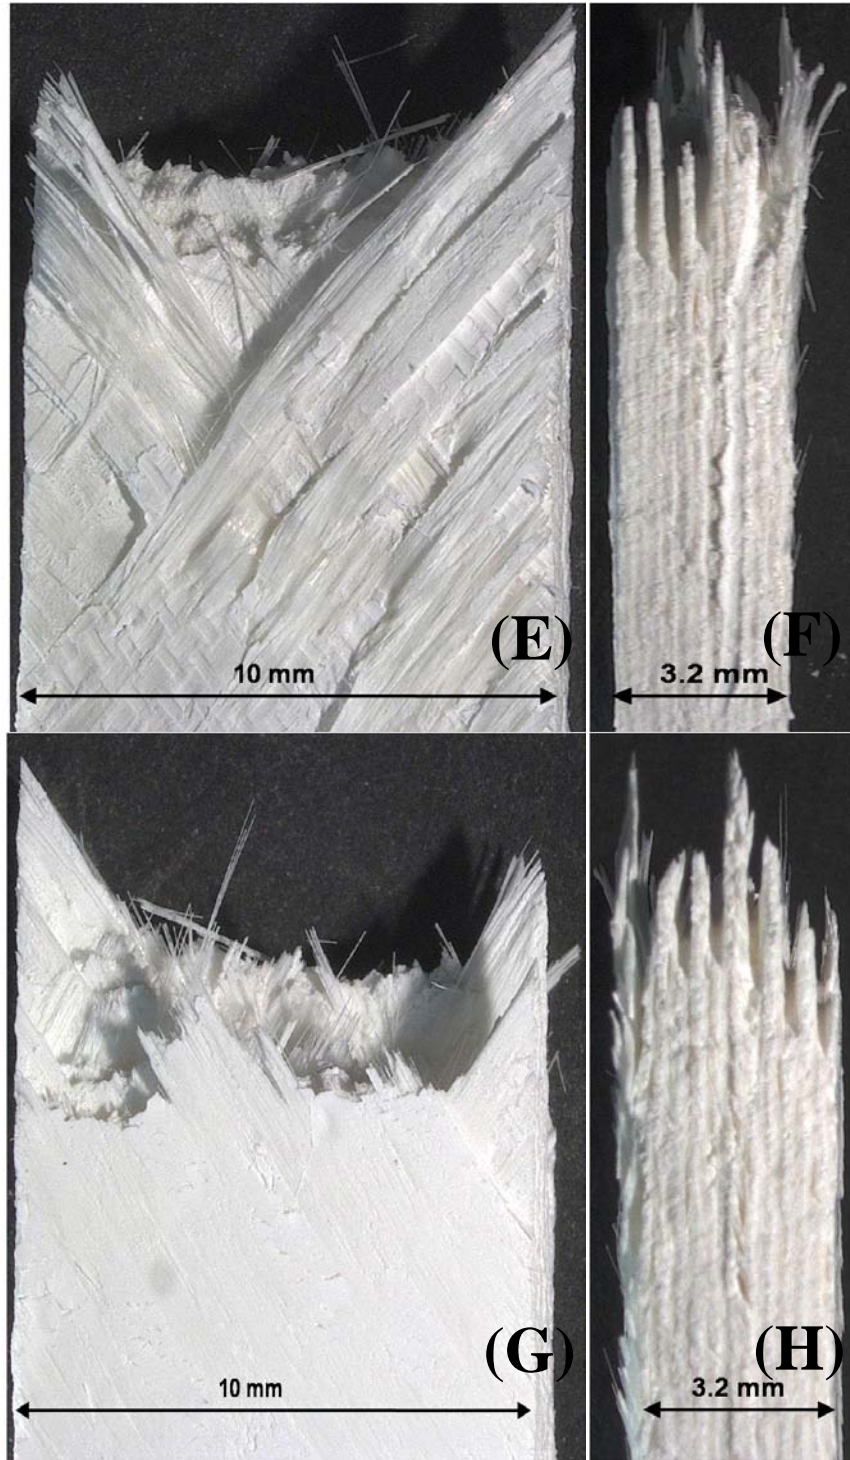
Figure 691. Fracture surface of the N720/AM specimen subjected to tensile test to failure with a constant stress rate of 0.0025 MPa/s at 1200°C in steam. (e)-(g): front view, (f)-(h): side view

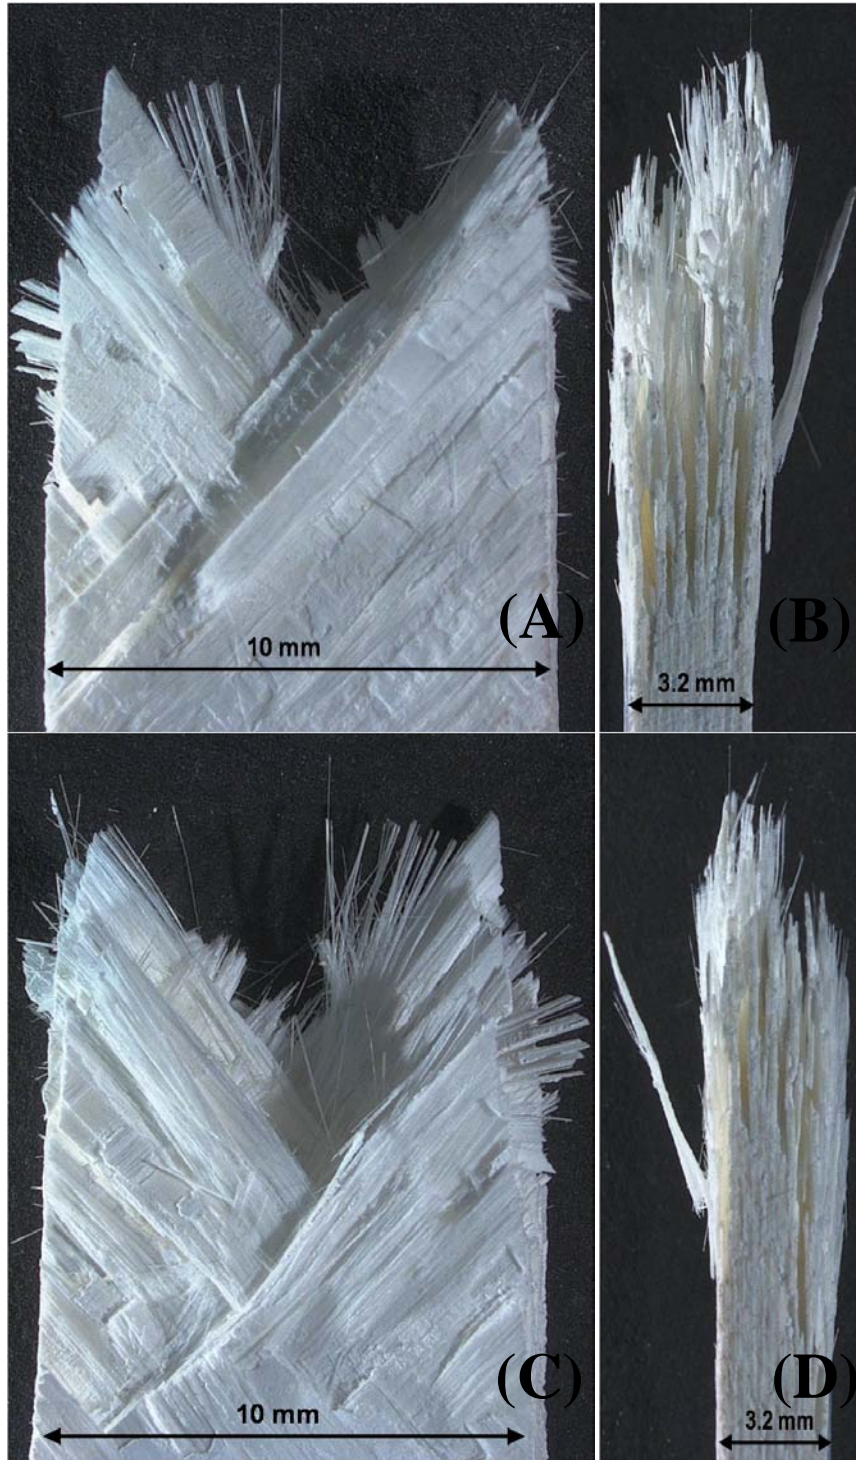
Figure 692. Fracture surface of the N720/AM specimen subjected to tensile test to failure with a constant stress rate of 25 MPa/s at 1200°C in laboratory air. (a)-(c): front view, (b)-(d): side view

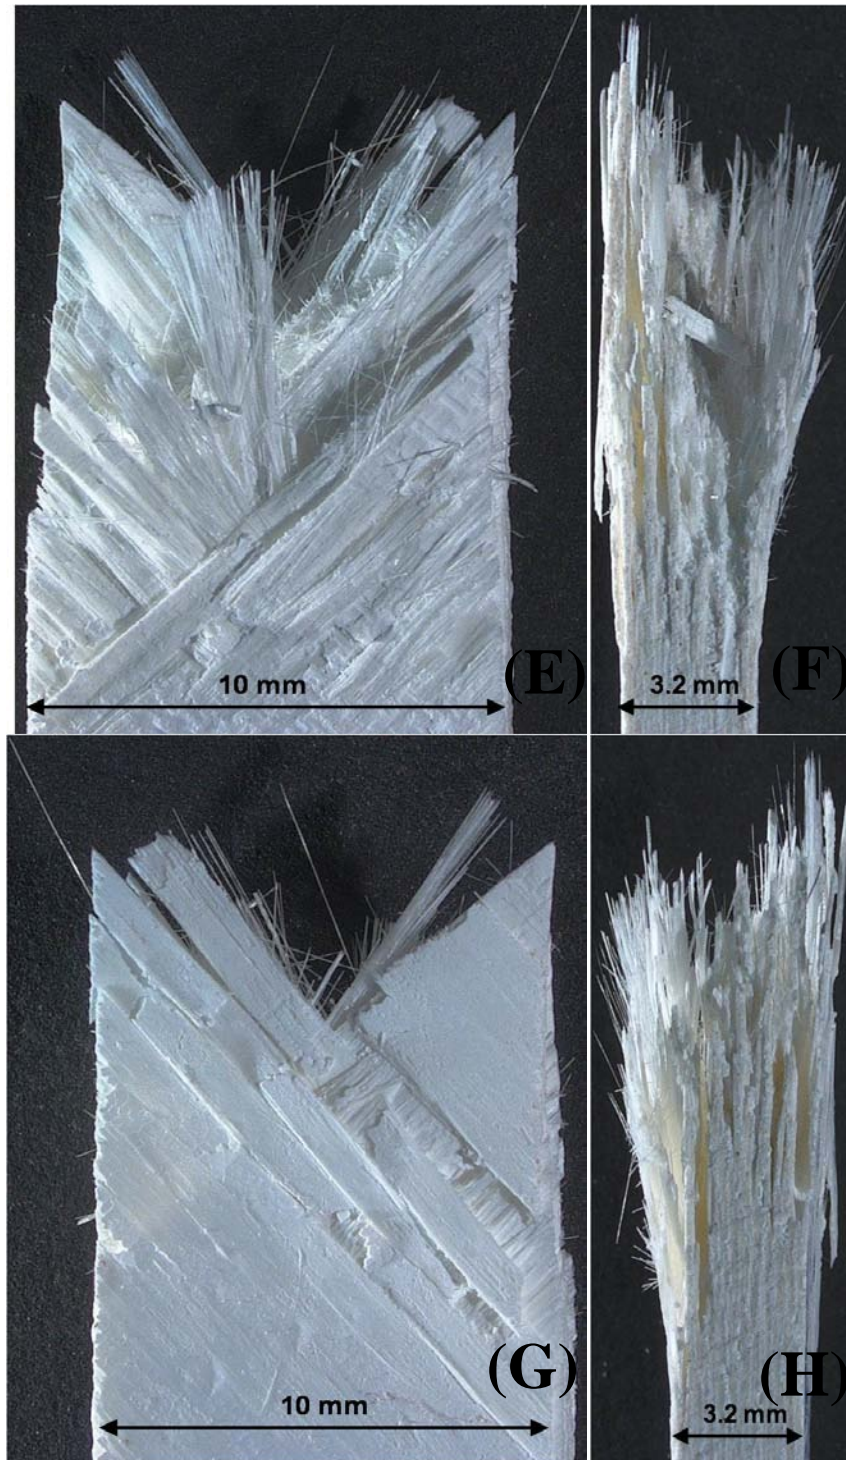
Figure 693. Fracture surface of the N720/AM specimen subjected to tensile test to failure with a constant stress rate of 25 MPa/s at 1200°C in laboratory air. (e)-(g): front view, (f)-(h): side view

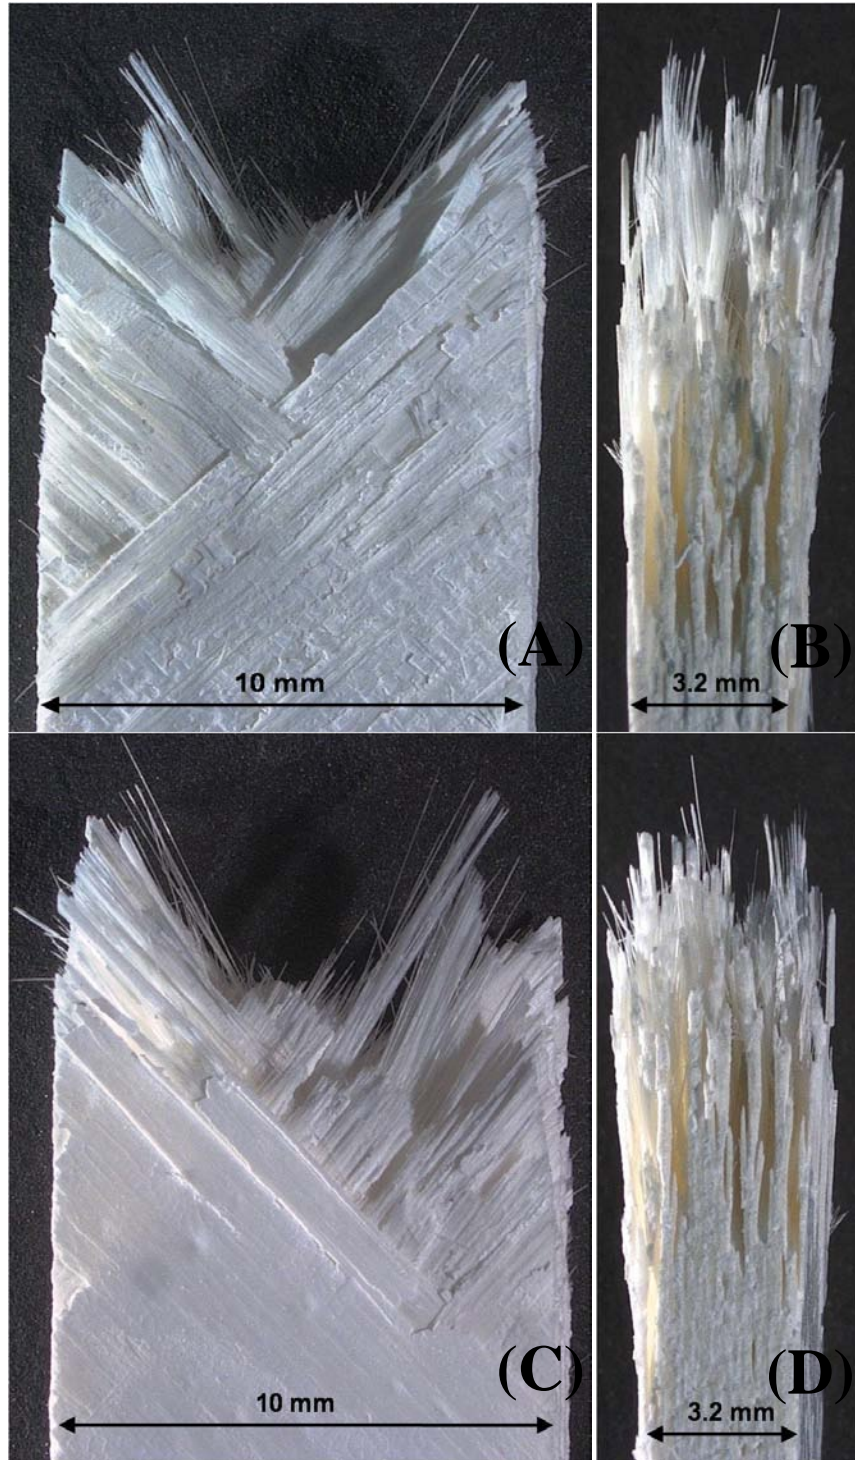
Figure 694. Fracture surface of the N720/AM specimen subjected to tensile test to failure with a constant stress rate of 25 MPa/s at 1200°C in steam. (a)-(c): front view, (b)-(d): side view
